# 2S Module Production – Debriefing

ETP 2S Module Production Meeting – 27.03.2025

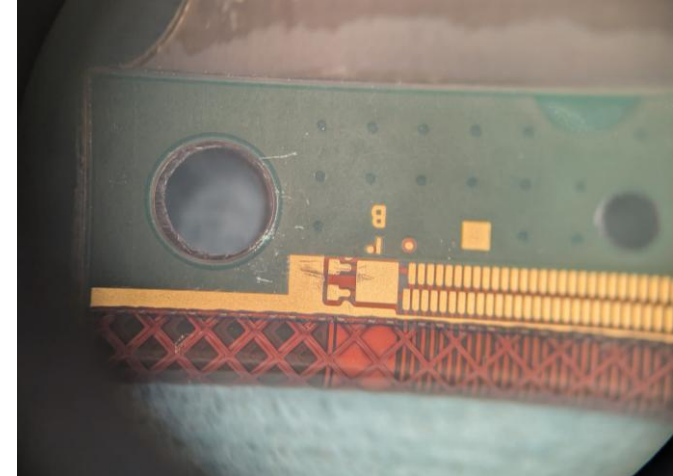
- Hybrid VI:
  - Leander identified 3 FEHs with scratches on the antenna and GND bond pads
  - We concluded that we identify such hybrids with a **red sticker** to make clear that wire-bonding might be problematic
    - Could also be done via the front-end but given the severity this is more straight forward and indicative
- Skeleton assembly is a time consuming step
  - We will try to stick and let it be done by HiWis, but this might not fully work out
- Skeleton test can be run while another one is assembled

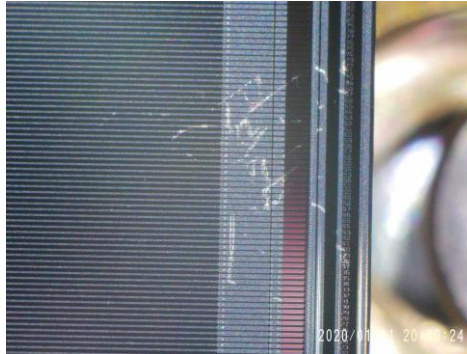
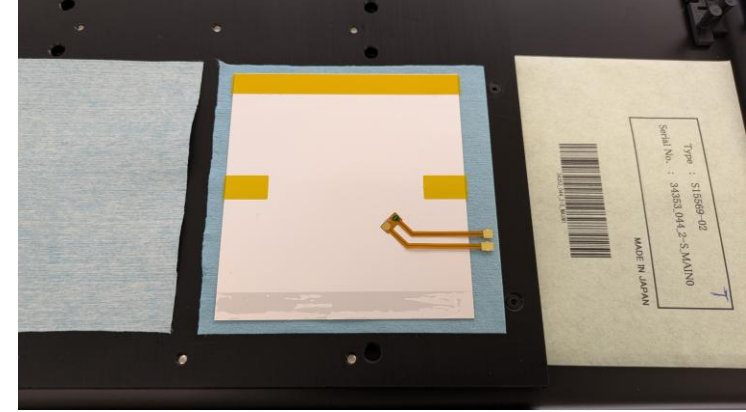
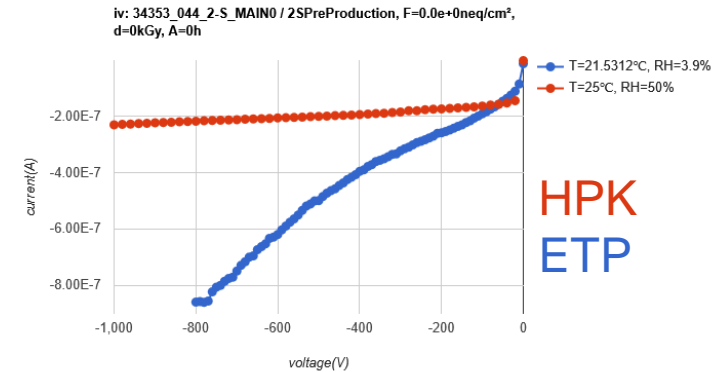
- Incident: Pickup tool stuck to sensor
  - Repairable
  - Increased IV curve. Not severe
  - Amount of glue in the pattern was reduced by 10%
- We try and stick to do the gluing in the morning shift
  - Keep 24h of curing as we need to wire-bond this in the morning
- Recheck of gluing in the afternoon
- Sensor showed some scratches during/after bare module assembly
  - Assumption:  
They come from the repair
- Buy dedicated dropper/pipette to apply isopropanol

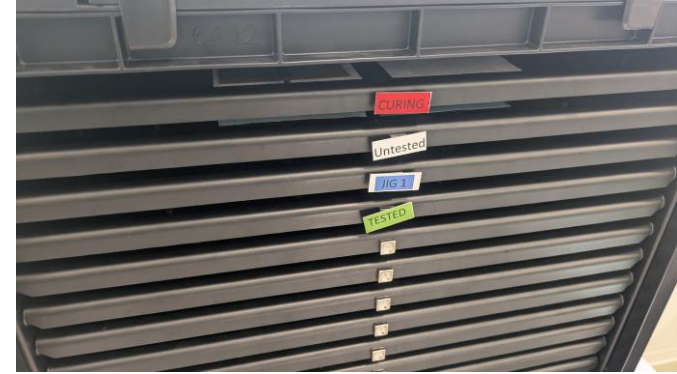
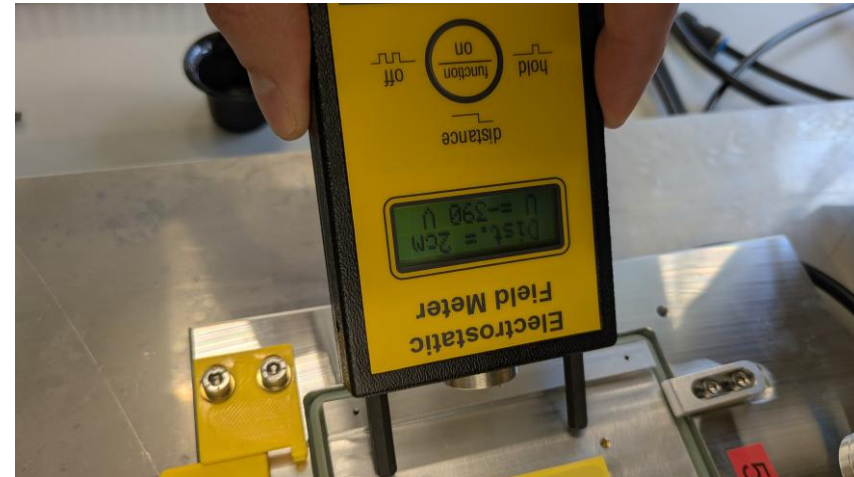
- Sensor tablets are now tagged:
  - One caveat: First person in the morning must change tags from curing to untested. Error Prone How does one know he /she is the first one? Ideas?
- Current recipe for measurement: 20 mins if everything goes well
  - Place sensor, attach HV tail
  - Place ion blower for 3-5 minutes
  - Place bias needle
  - Wait for 5% RH
  - Measure
- Problem sensors do charge up / are charged up after the HV test
  - We had >500V on the jig after the measurement!
  - Check relay setting and investigate
  - Possible damage on sensors?  
(See later damaged channels)

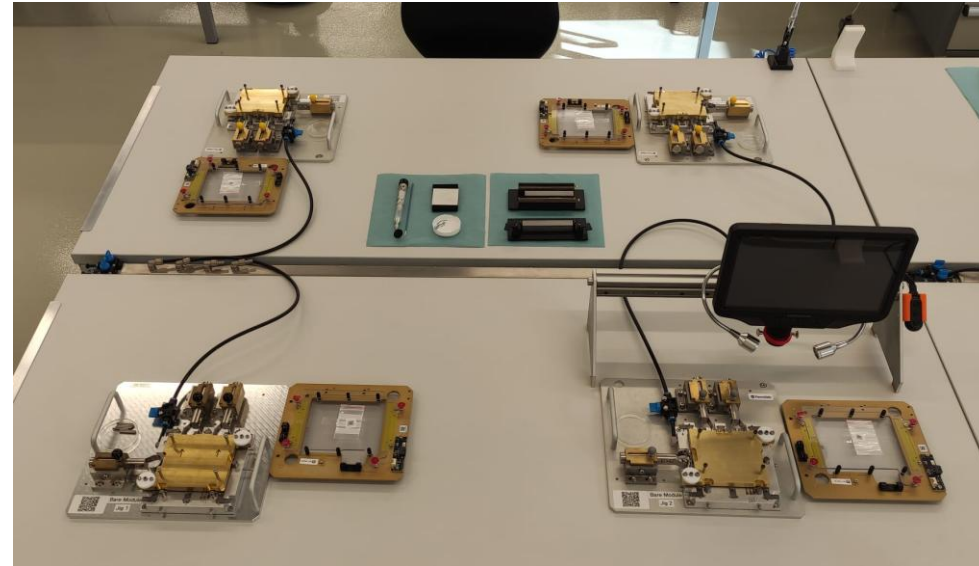
- Space sufficient for 2 jigs/table?
- Different jigs yield slightly different alignment results
  - Eager to see trends
  - Recheck alignment pins
- Jig #3 base plate uneven?

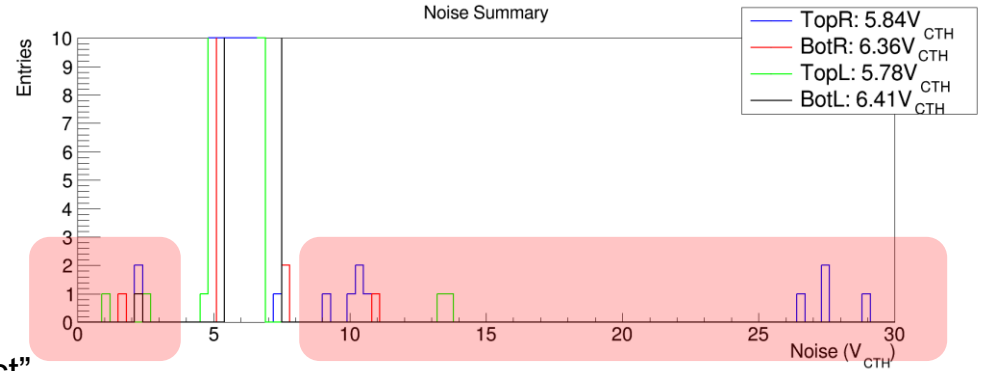
1014 unconnected  
692 unconnected  
693 noisy  
954 noisy  
955 noisy  
956 noisy  
962 noisy  
963 noisy  
964 unconnected  
969 noisy  
970 unconnected

Scratched area

Most likely scratch

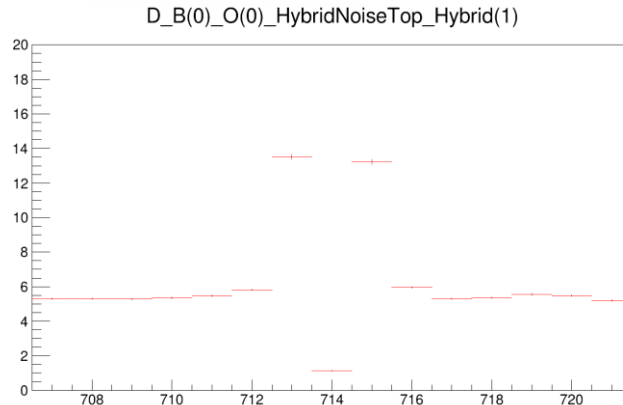
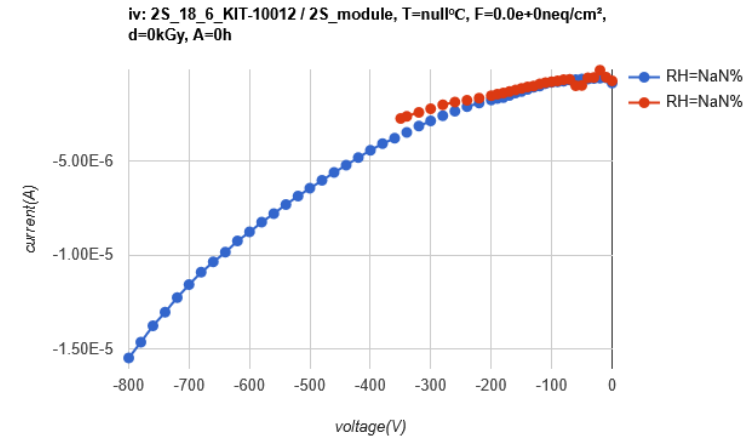
- New failure mode (1 Module in October and one this time)
- Single channel increases global leakage current significantly
- Until we do not understand the cause and the impact on operation we must identify these channels and pull the corresponding channel
  - We will start testing how this is triggered and its impact
