Backscattering setup @ MiB

Matteo Biassoni
TRISTAN Workshop, KIT July 2022

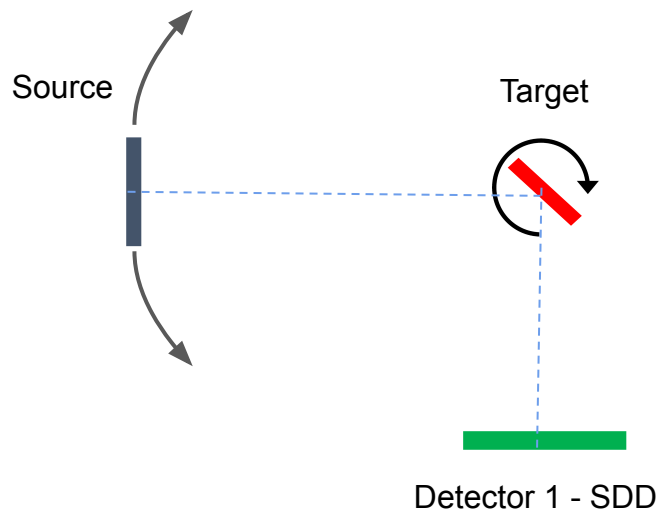
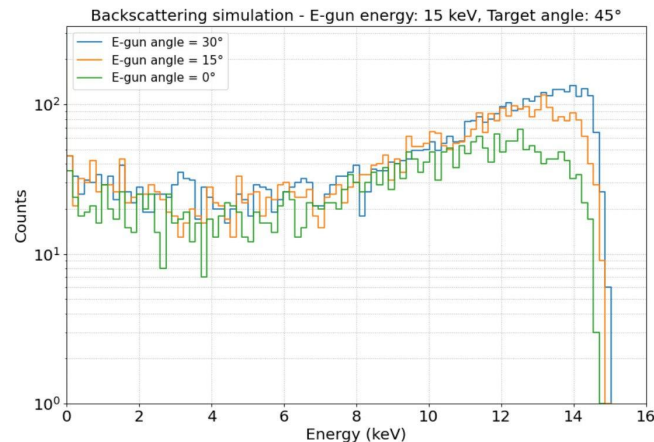
Leverage knowledge of SDDs response to electrons to perform backscattered electrons spectroscopy!

Compare data with simulation while changing: energy, incident angle, scattering angle

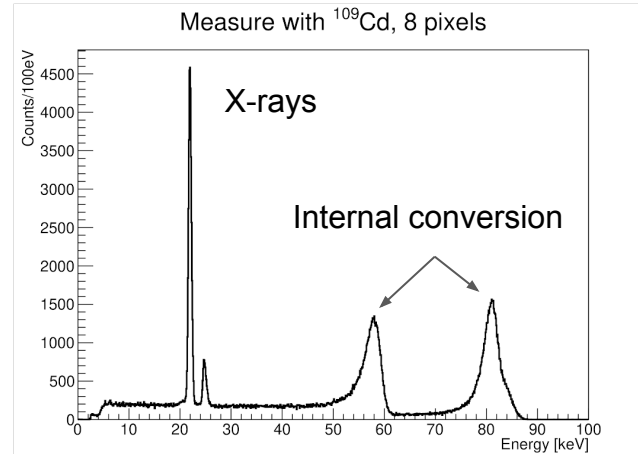
Source reference
spectrum

- radioactive source (^{109}Cd)
- very small backscattering detection probability (small geometric efficiency)
- large background from direct detector illumination (isotropic source)

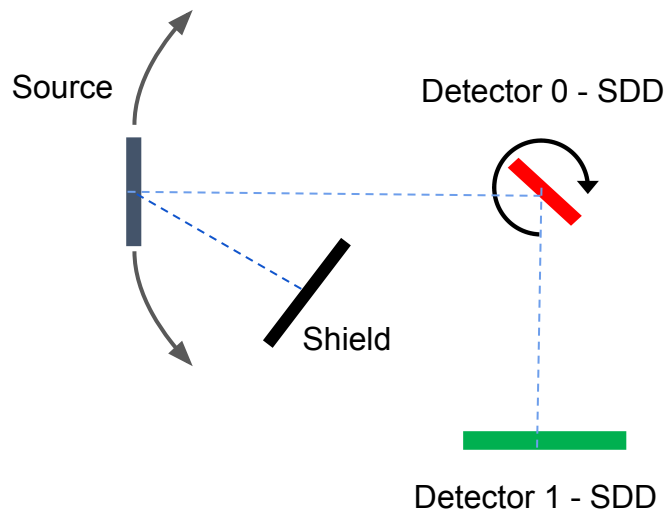
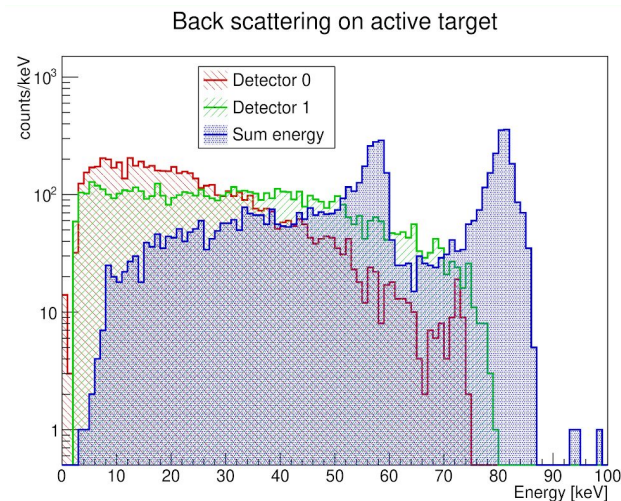
Leverage knowledge of SDDs response to electrons to perform backscattered electrons spectroscopy! Improved configuration

Detector 0 = single pixel SDD

Detector 1 = 12 pixel Tristan matrix

Selection of multiplicity 2 events (both detectors trigger)

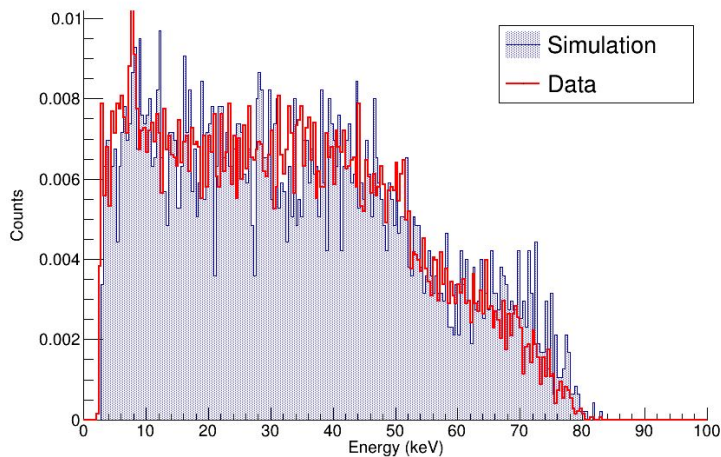
Detector 1

Very good agreement between data and simulation, but **source self-absorption** and **low geometrical efficiency** is limiting the sensitivity

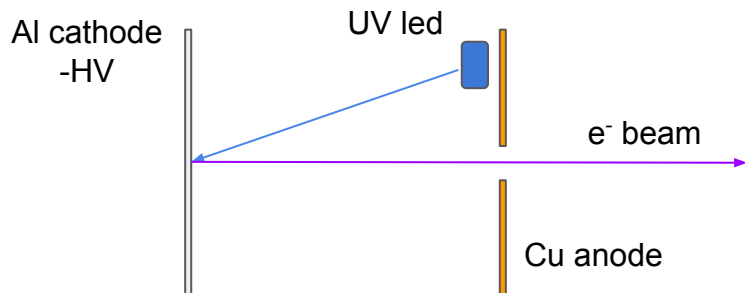
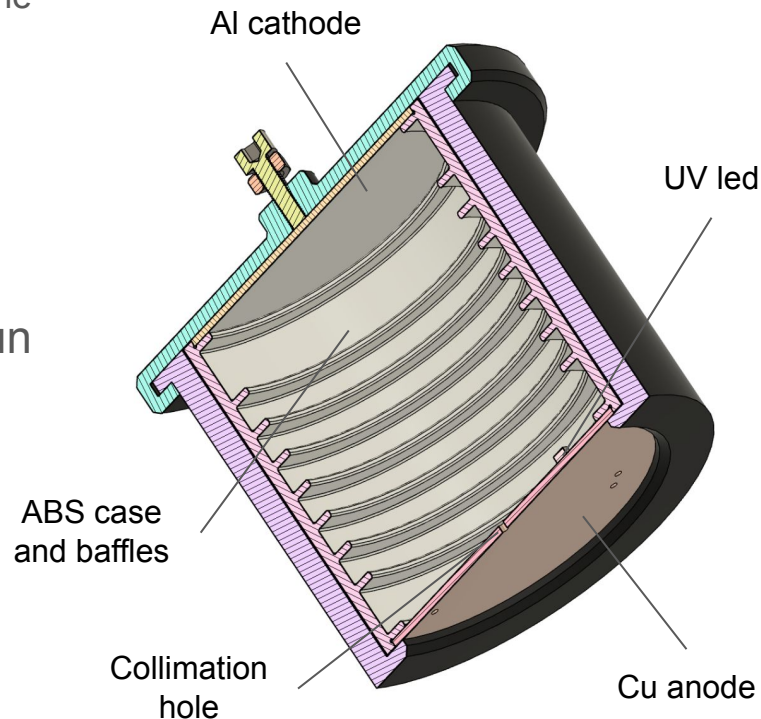
- Ideal source features
 - monochromatic (at the ~ 10 eV level or better) in the relevant range (few to few tens of keV)
 - collimated (known incident angle and increase geometric efficiency)
 - controllable electron flux
 - compact and easy to move (change angle and position)
- current implementation: UV-led based e-gun

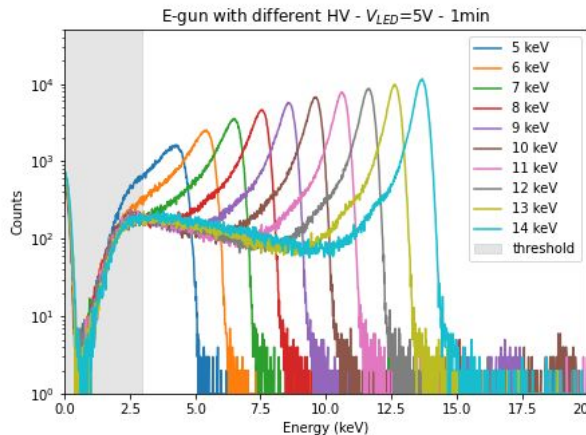
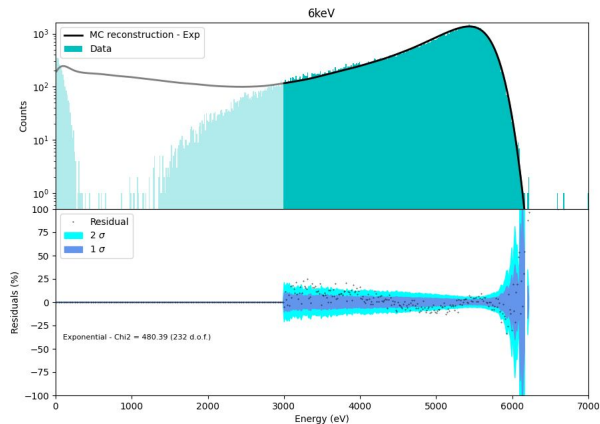
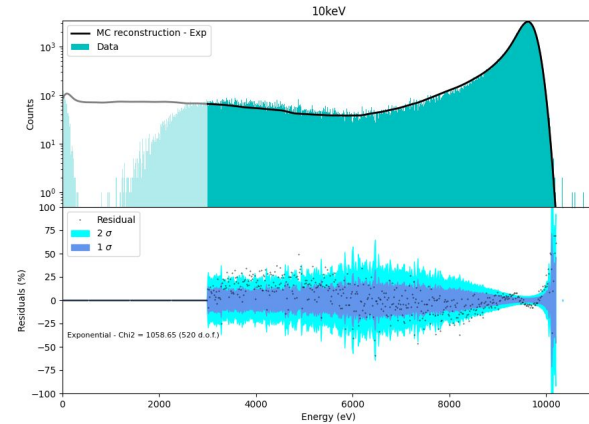
New response function fits

- Data with beam pointed directly at SDD (used for detector response fits, charge sharing, etc...) show very promising spectral shape

1 min runs

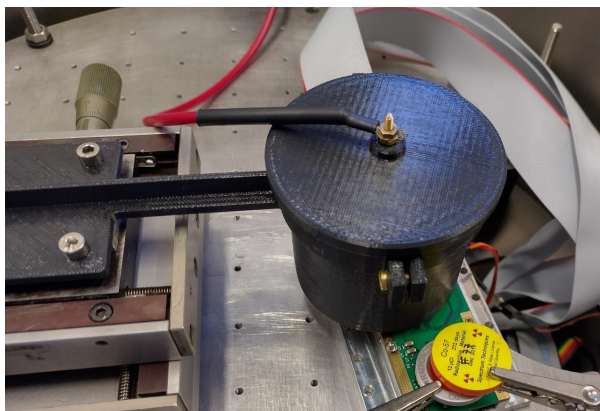
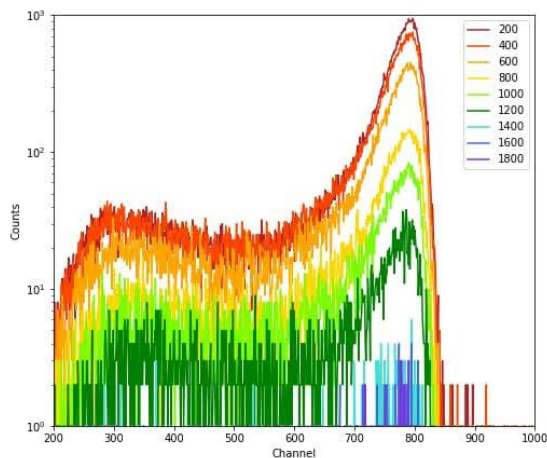
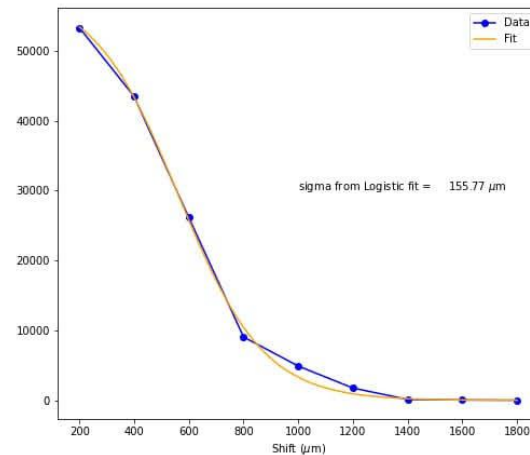
Beam cross section study

- Data with beam pointed directly at SDD (used for detector response fits, charge sharing, etc...) show very promising spectral shape

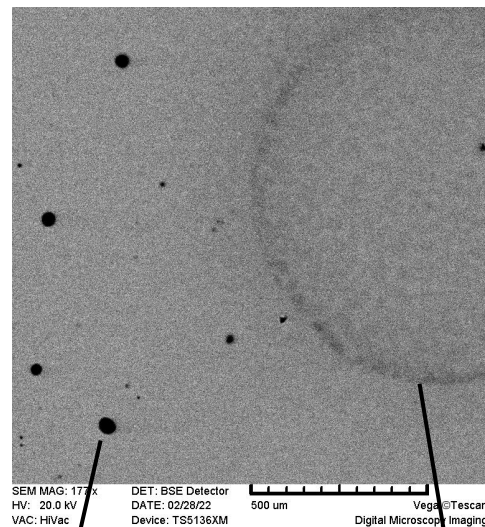
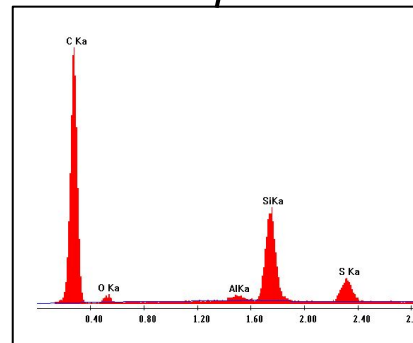
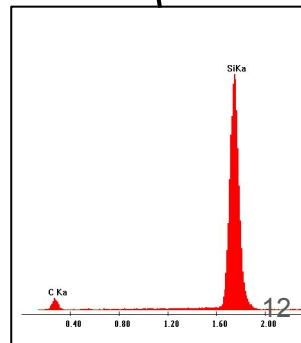
- PROBLEM: instability at large acceleration potentials (>15 kV)
 - large electron rate fluctuations/spikes
 - large current from HV generator
 - electronics misbehaviours
- after one of these “traumatic” events the pixel where the beam was pointing was damaged (larger leakage current) and had visible “halo” on the surface
- performed micro-analysis at SEM: coating of C-reach material plus C particles with small amount of Al
- most likely explanation: residual gas from solvents (electrical tape was being used, now replaced with kapton tape)
- after this tests second stage of Ettore ASIC stopped working → no more acquisition with CAEN multi-channel DAQ (new Ettore on its way as also first stage stopped working after some more tests!)

Decision to switch to backscattering measurements with $E < 15$ keV to avoid damaging more pixels

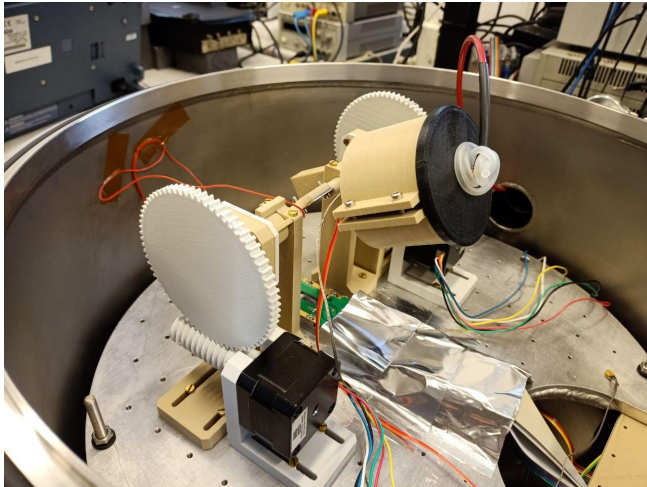
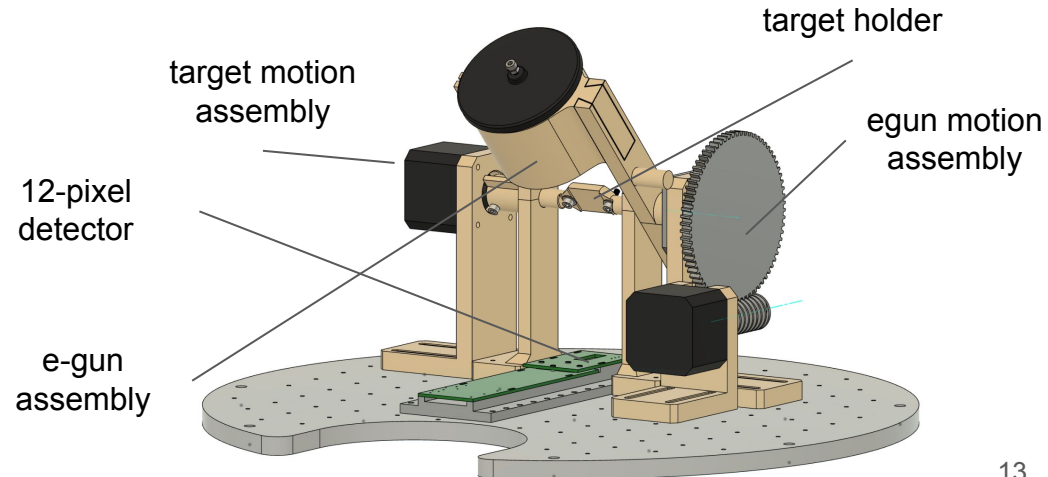
- Build setup for backscattering measurement with passive target:
 - passive target to test different materials (possible thanks to higher geometric efficiency)
 - move egun and target without breaking vacuum → fully motorized movements of source and target

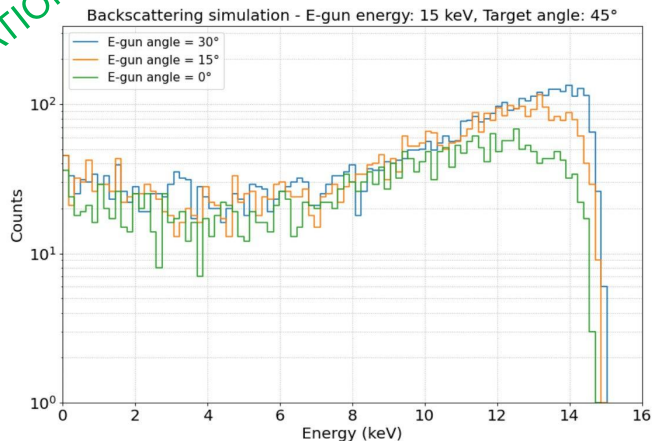
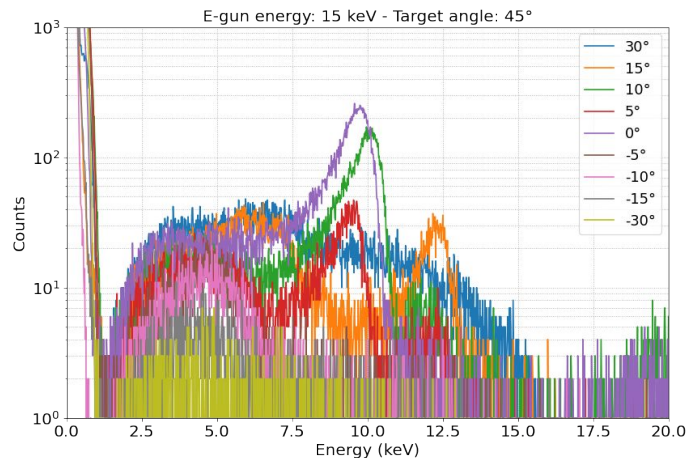
EXPECTATION

Data clearly show unexpected structures and features:

- not compatible with expected BS spectra (present also in runs without target)
- strong angular dependence
- peak-like structures at unexpected energy
- very low rate (many orders of magnitude smaller than “main beam” rate)

24 h runs

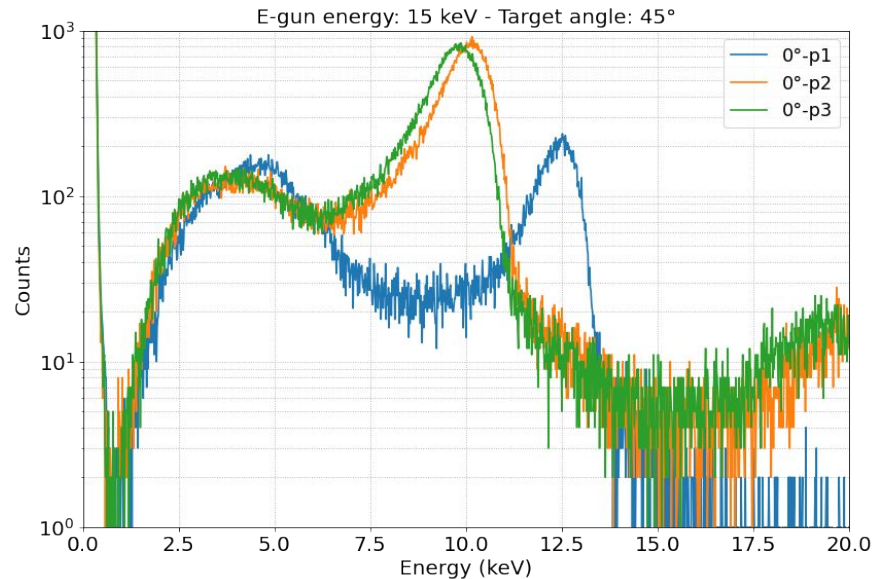
Data clearly show unexpected structures and features:

- relatively (but not completely) repeatable

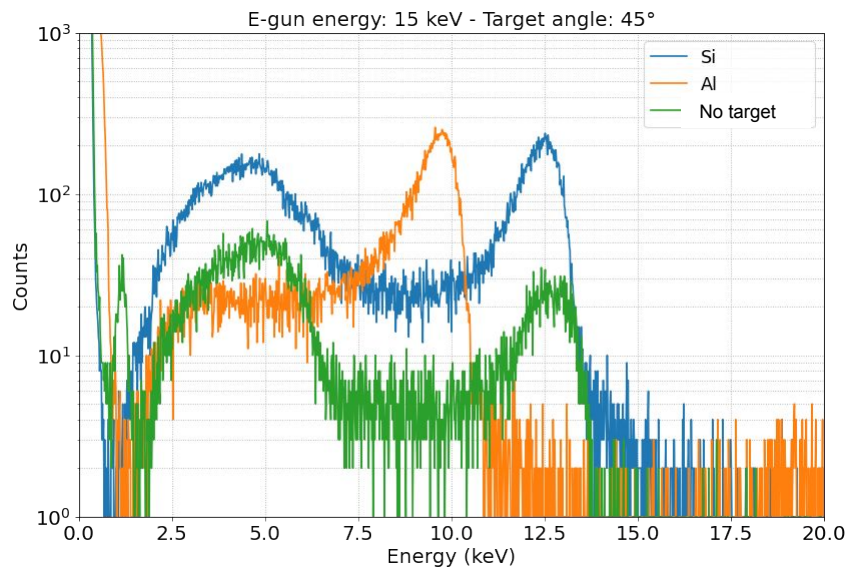
We performed many test to exclude:

- polarization of target (replace original Si target with grounded Al sample)
- transient effects
- correlation with LEDs or HV instabilities

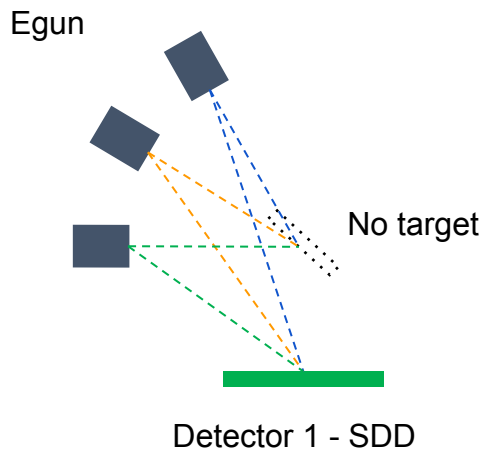
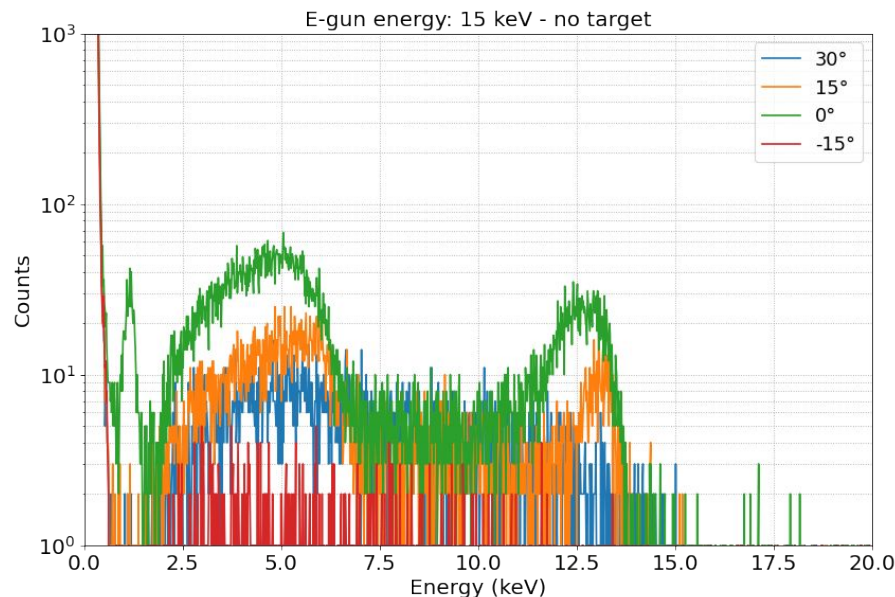
We performed many test to exclude:

- perform angular scan without target
- effectively corresponds to looking at off-axis electrons

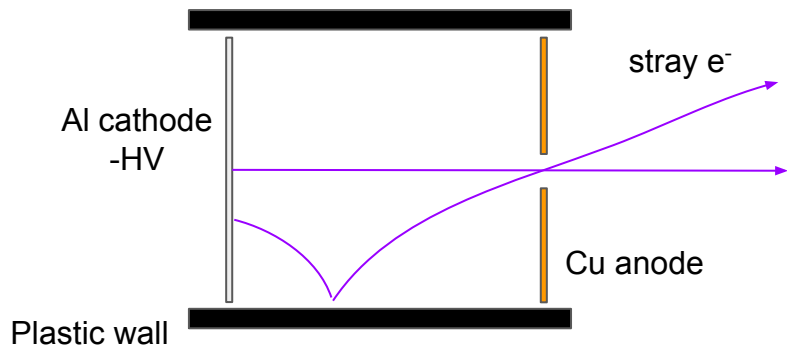
Current most likely explanation (but not very convincing): stray electrons diverging from main beam, produced in a different position w.r.t. the cathode:

- diffused from inner egun walls (plastics) when charged during operation
- from residual gas ionization

Not clear if really this electrons can be guided through the hole in the anode, would need a simulation of the fields with dielectric components (not available at the moment)

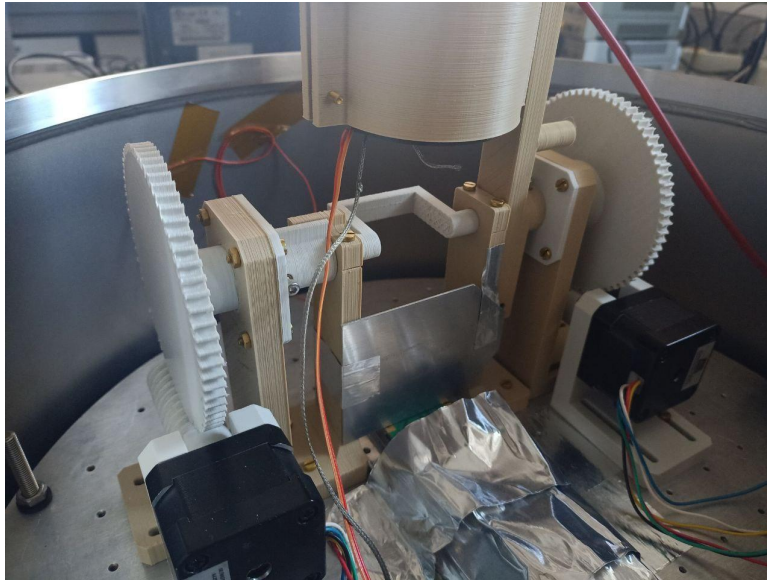
- add baffle to block direct line of view to the detector. Temporary solution to go on with the measurements

Already implemented but not tested as ASIC stopped working right before this...
