# TRISTAN Radiation Damage Test Status

TRISTAN workshop 2022 – Karlsruhe

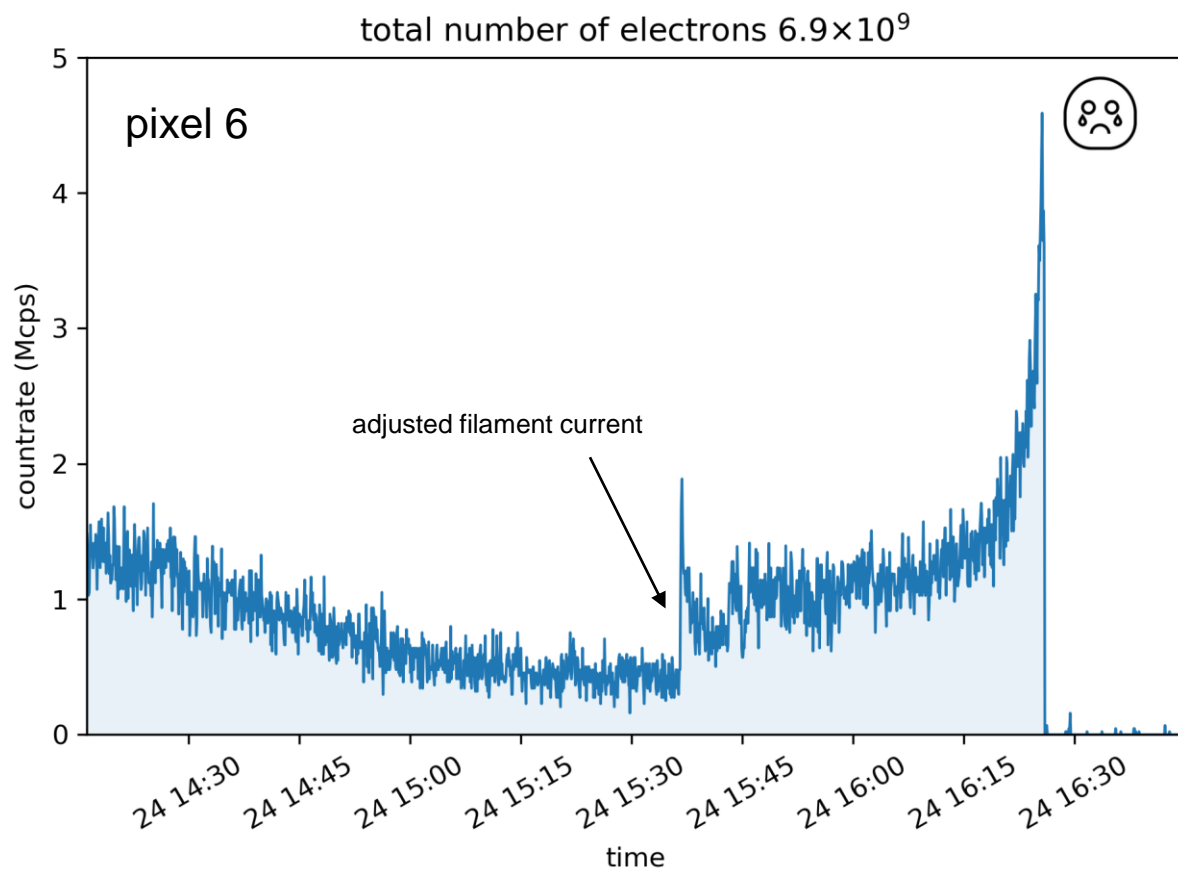
# Irradiation #1

- shutter in half-open position, HV at 10 kV
- total  $\sim 7E9$  electrons

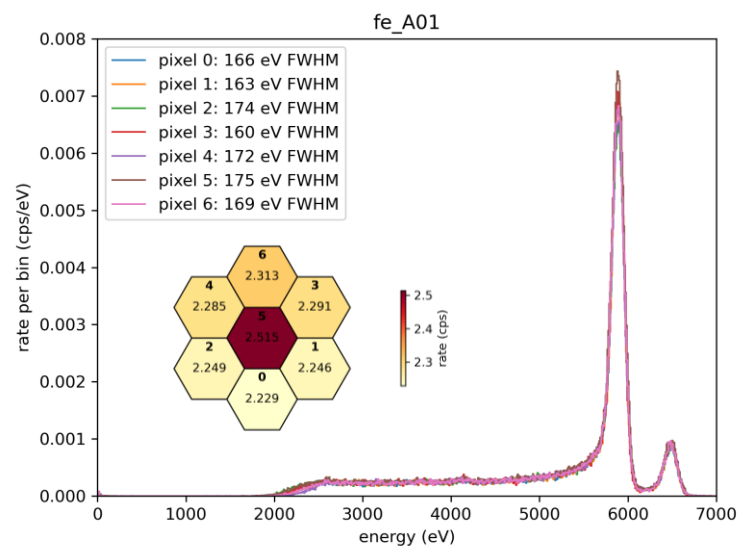
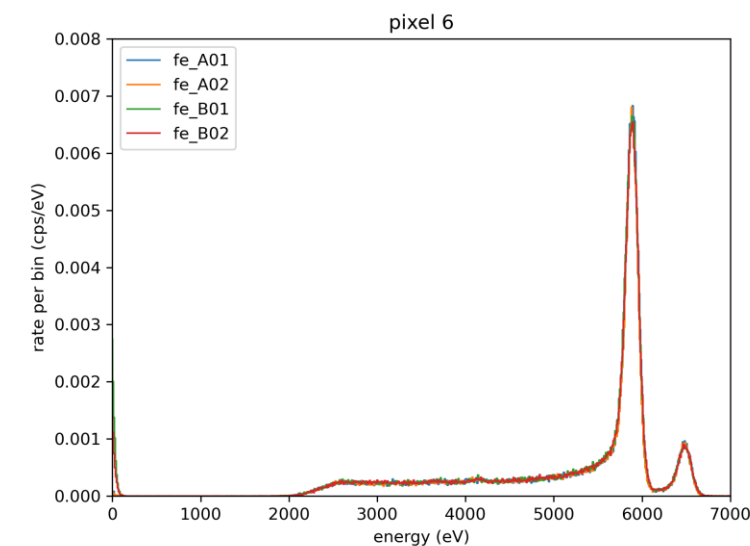
# Spectra

- $^{55}\text{Fe}$  measurements look consistent
- no significant degradation found

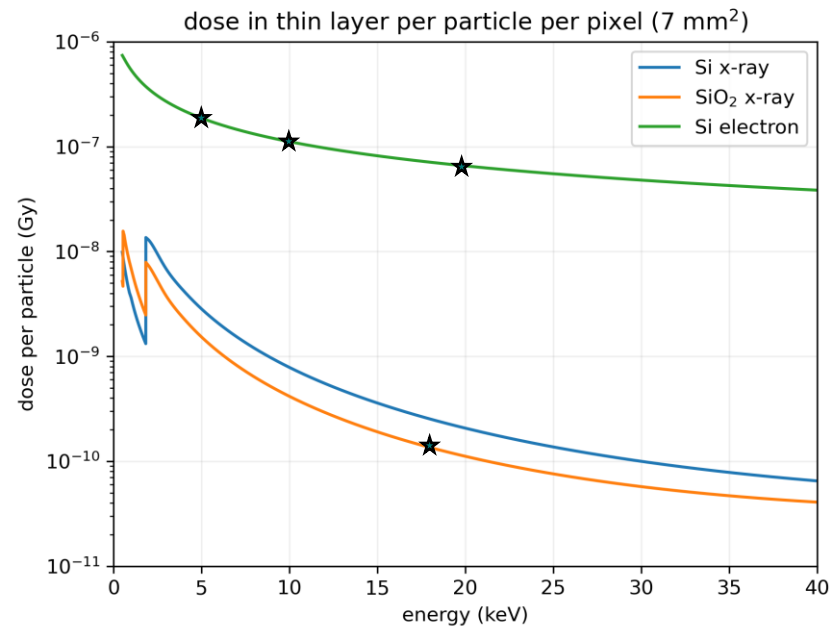
1 years at 30 kcps

- Example KATRIN FBM: 1E12 electrons (5 keV) on 0.05 mm<sup>2</sup> → **30000 kGy** at the SiO2
- Example THC damage test: 7E9 electrons (10keV) on 0.05 mm<sup>2</sup> → **100 kGy** at the SiO2
