# Vibration analysis and stability controlling for High Energy Photo Source in China

YAN Fang

HEPS, IHEP, Beijing China

IFAST 2025.3.17-2024.3.22 Karlsruhe, Germany

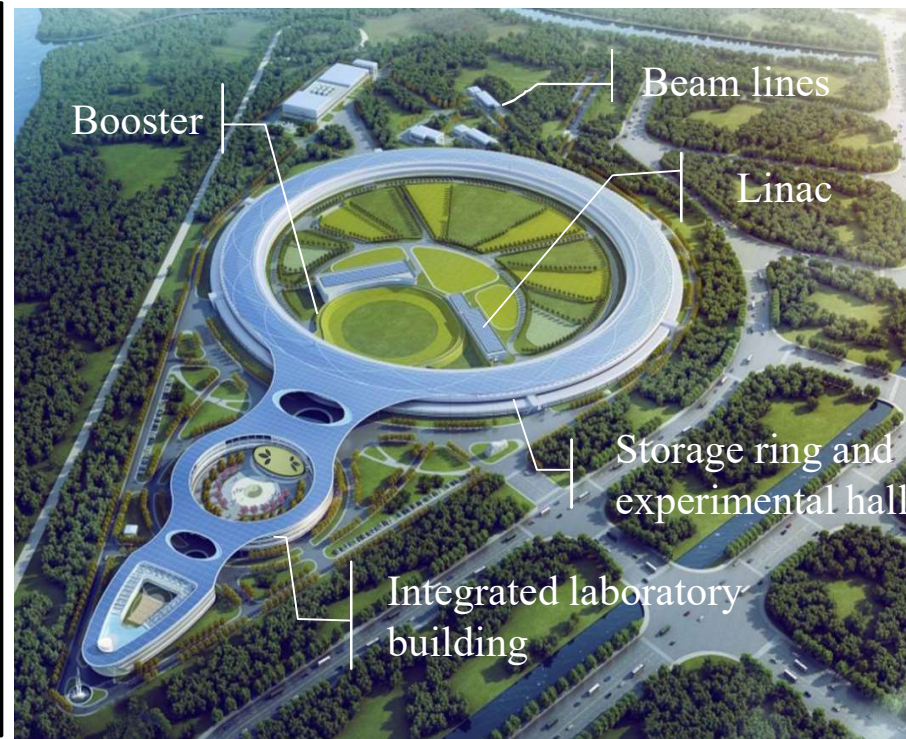
Location at Beijing China : Huairou District

SR & booster Energy : 6 GeV / 500MeV

Designed natural emittance: 34.82 pm.rad

Circumference : 1360.4 m

Beam current : 200 mA

Lattice design : 48 hybrid 7BAs

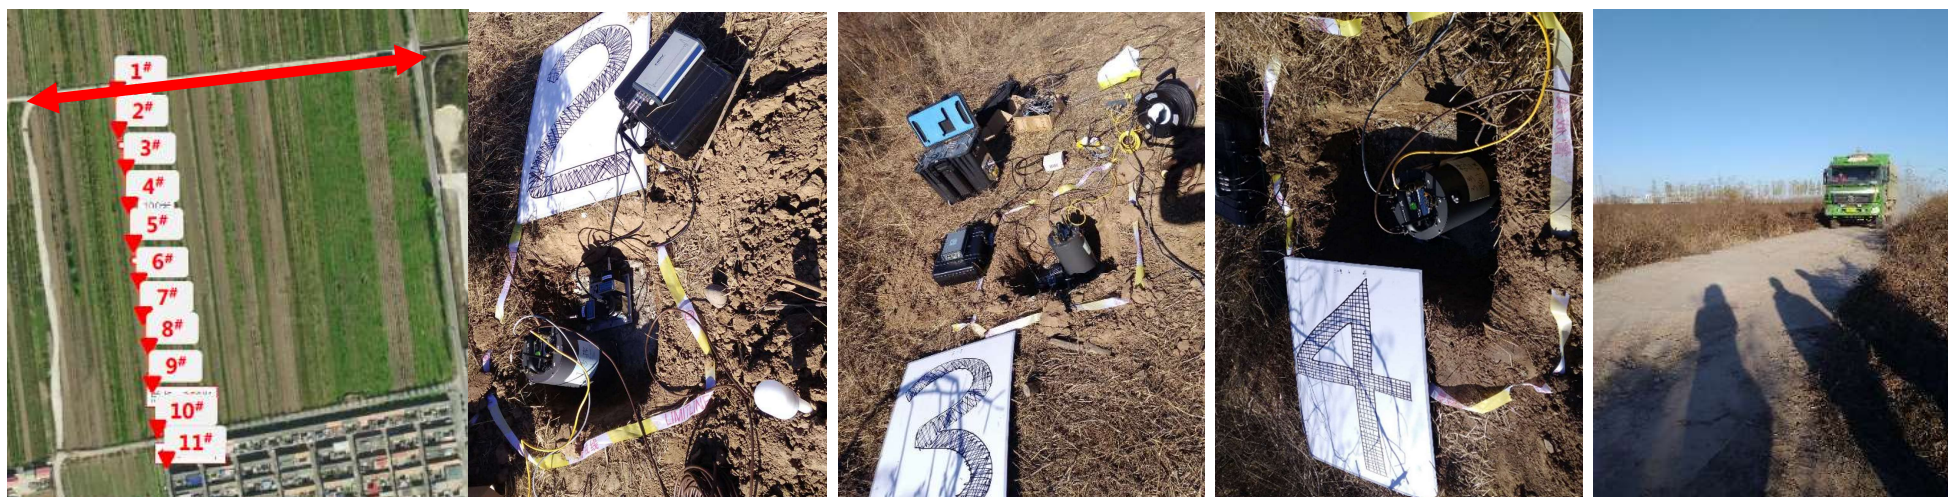
- Three sensors equipped with GPS were placed at 2#/3#/4# locations of HEPS site, the distance in between is 30m long.
- A truck with 30t load was arranged to run on the perpendicular direction of the measurement line as a vibration source.

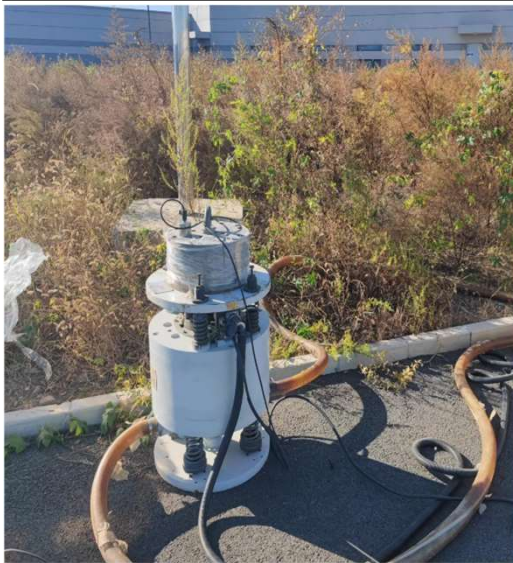
Vibration generator

- 1~100Hz signal
- forces of 1-70kN
- Weight: 1 ton

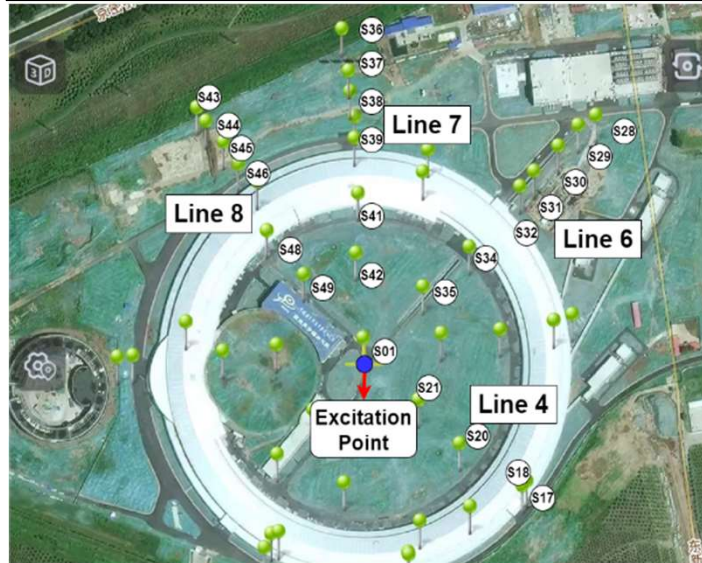
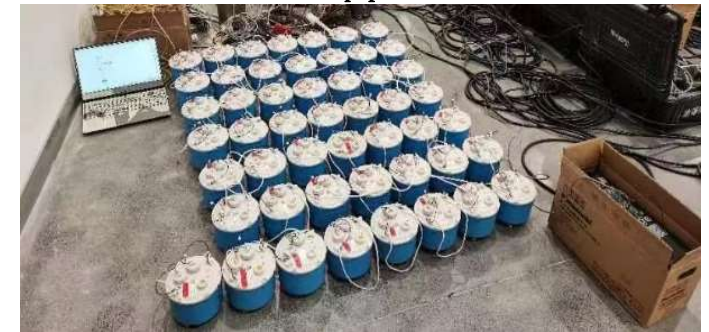
Exciting at center of the ring

- 4 testing lines / max. 395m
- Smartsolo Seismic node
- 0.2~1000 Hz / 76.7 V/m/s

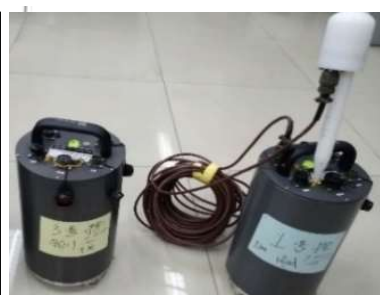
- Time: 2019.4.18~2019.4.29 (a week)
- Major vibration source: traffic on a civil road inside HEPS site(closed now).
- Seismometer positions:
  - ✓ One sensor is on ground closer to the internal site road.
  - ✓ Another sensor is on the ground of the storage ring.

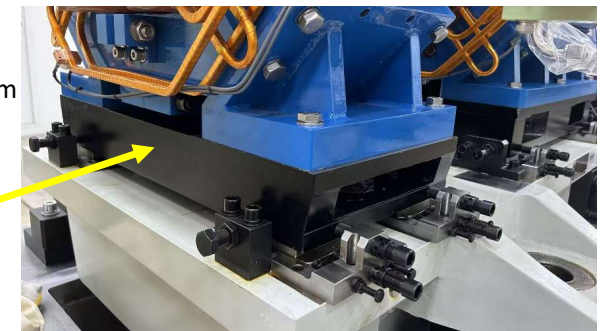
- All 288 support modules have been tested after the alignment in the tunnel, and all meet the requirements.

- Eigen frequency:  $\geq 70$  Hz
- Transmissibility:  $\leq 1.05$

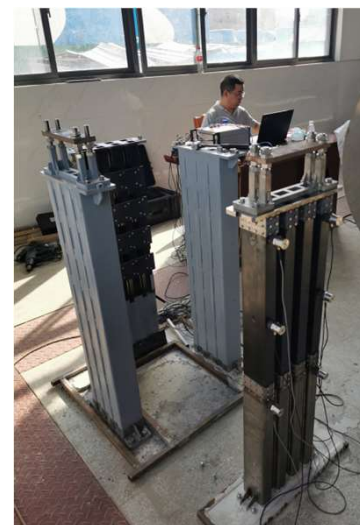
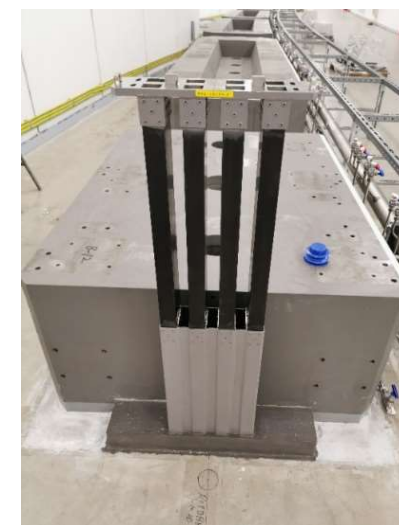
- Carbon fibre (upper half) and invar alloy (lower half) bounded by epoxy-resin & fixed with rivet to give better magnet permeability.
- Grouting at the bottom.
- BPM girder: eigen frequency  $\geq 66\text{Hz}$ , magnification factor  $\leq 1.05$
- Thermal stability :  $\pm 20\text{nm}$ ;  $\mu < 1.02$  (No magnetic field within 670mm of the beam)

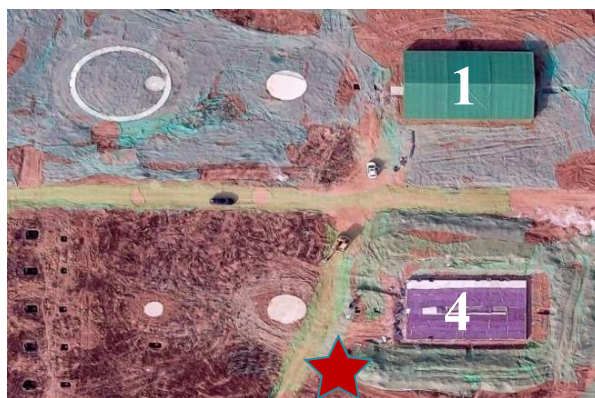
- Two prototypes (slab 1 & Slab 4) were fabricated in HEPS site;
- Slab 4 & slab 1 are all the same for the top two layers, except extra 5m grouting layer for slab 4;
- Comparing with measurement point (red star position) on ground, vibrations are magnified a lot on slab 1, but almost the same level on slab 4.

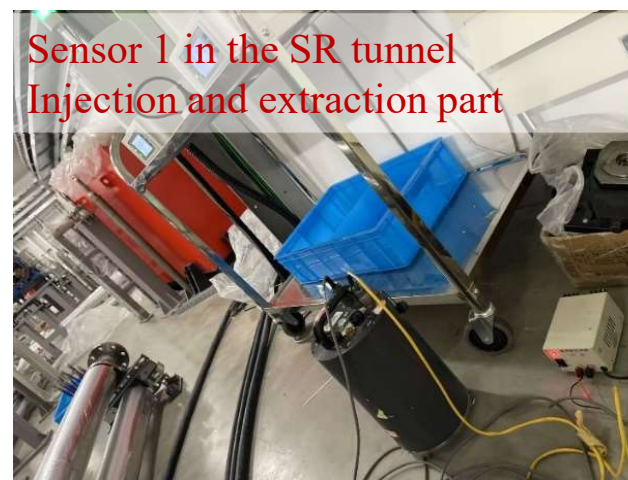
- The same measurement has been done in the HEPS SR and booster tunnel during booster commissioning during year of 2024.
- A 1.1Hz peak appears in booster tunnel but not in SR tunnel;
- The detached foundation design is proved effective.

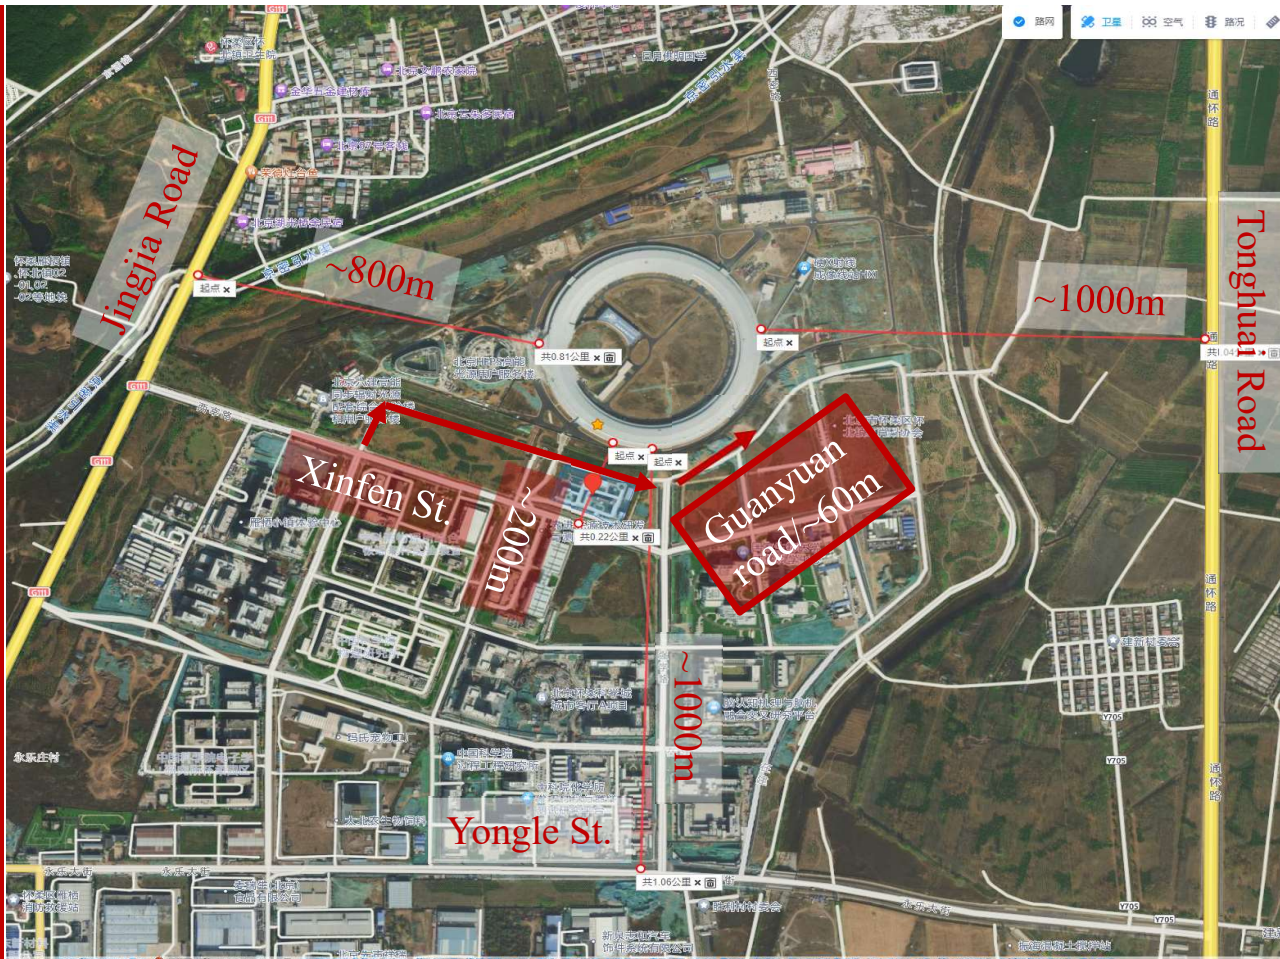
HEPS surrounding transportation

- There are 3 major road around HEPS campus, which is 800-1000 meters away;
- The closest is Guanyuan (GY), road, which is ~60m away;
- Xinfen St. is further than GY road which is about 200m away.

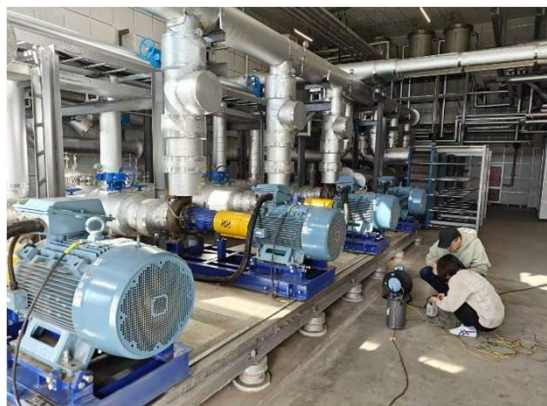
- The mechanical vibration is traced to a cooling pump close to the R42 period.
- The pump is in the service building of inner side of the ring.
- The vibration frequency is 49.6Hz.
- The vibration has a 4min cycle because of water flow fluctuation.
- The max. displacement RMS on slab is ~6nm vertically.

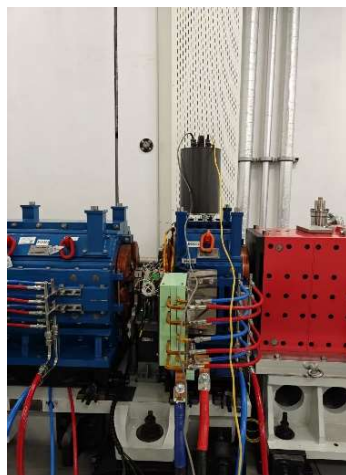
- The vibration is magnified horizontally but damped vertically on the magnet.
- The vibration influence to the beam is simulated by the point wave model.
- The results shows that the pump has effects to the beam, but seems not the major cause.
- The reason of the 50Hz vibration of the beam is still under investigation.
