# 2S Module Production – Debriefing

ETP 2S Module Production Meeting – 27.03.2025

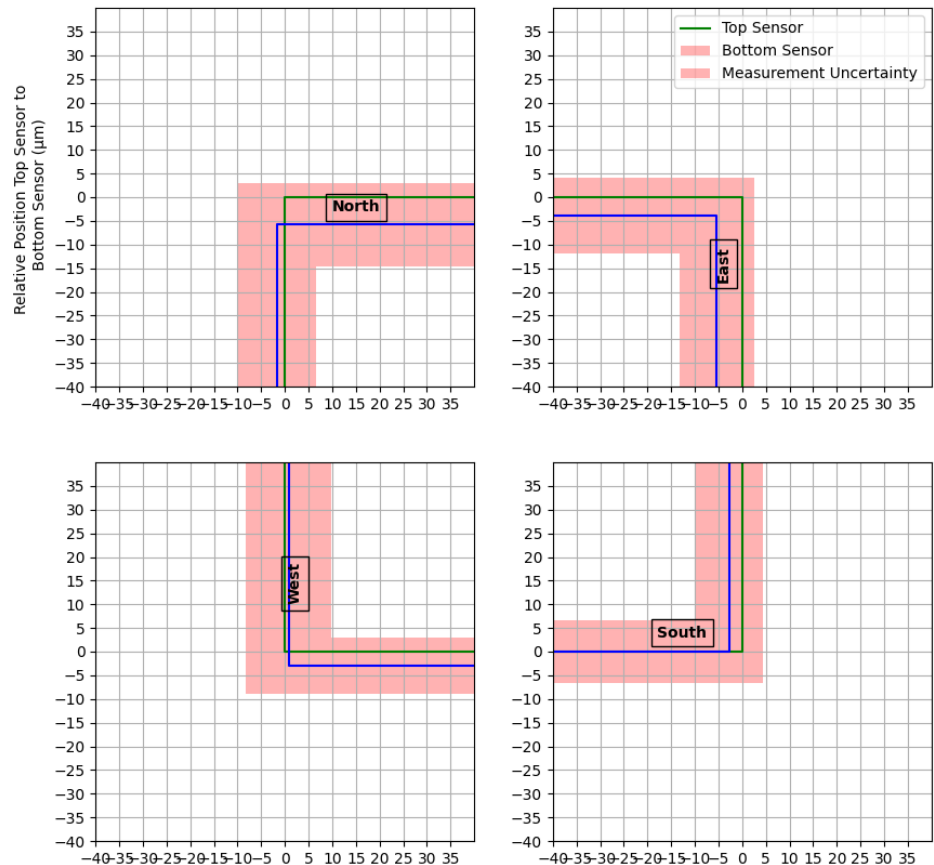
# Modul 12

- Space sufficient for 2 jigs/table?
- Different jigs yield slightly different alignment results
  - Eager to see trends
  - Recheck alignment pins
- Jig #3 base plate uneven?

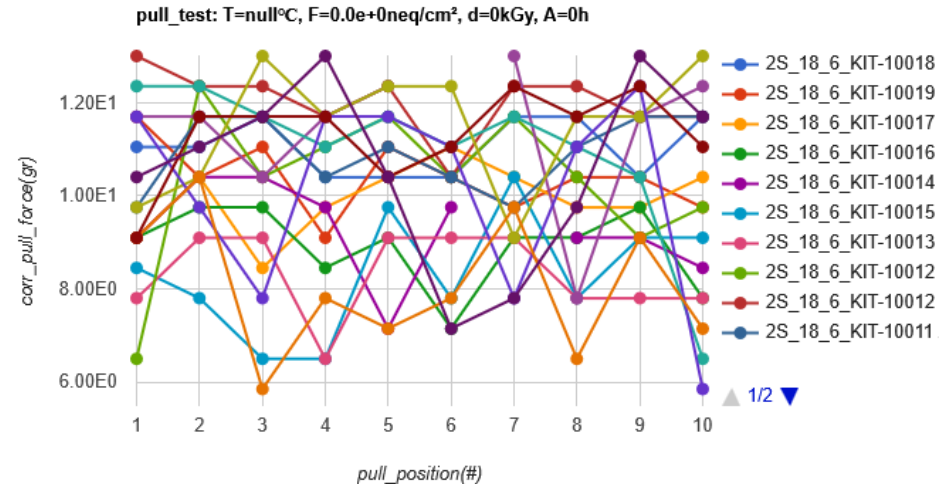
- In general even smoother than in October
- 4 modules and 20 pull test wire-bonds: 4 hours and 30 minutes
- Where is the bottleneck?
  - → PARTS
- All pull test values between 6 and 13 g
- Add dedicated microscope to make these pull tests and to inspect modules (?)

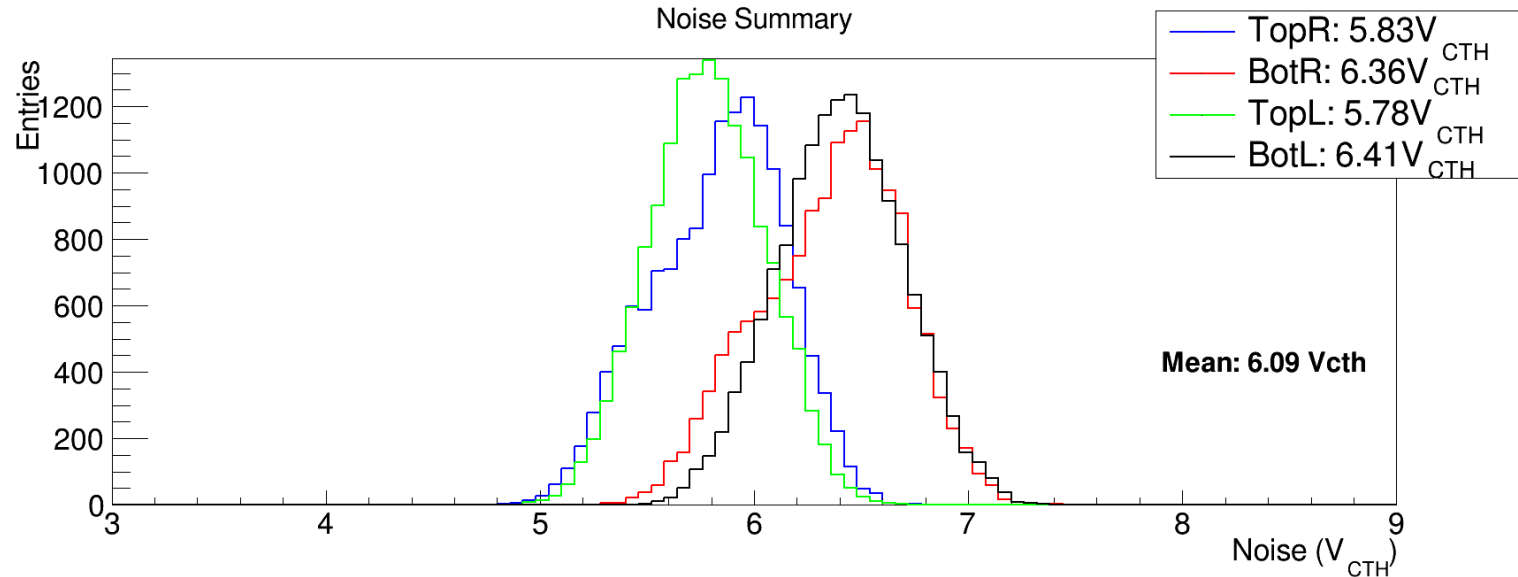
# Module Test (2) - Noise

- New failure mode (1 Module in October and one this time)
- Single channel increases global leakage current significantly
- Until we do not understand the cause and the impact on operation we must identify these channels and pull the corresponding channel
  - We will start testing how this is triggered and its impact
